Office of the State Comptroller  
Annual Report 70C | 2021

# Aspects of Safety and Responsibility in Relation to Road Maintenance in the Judea and Samaria Region

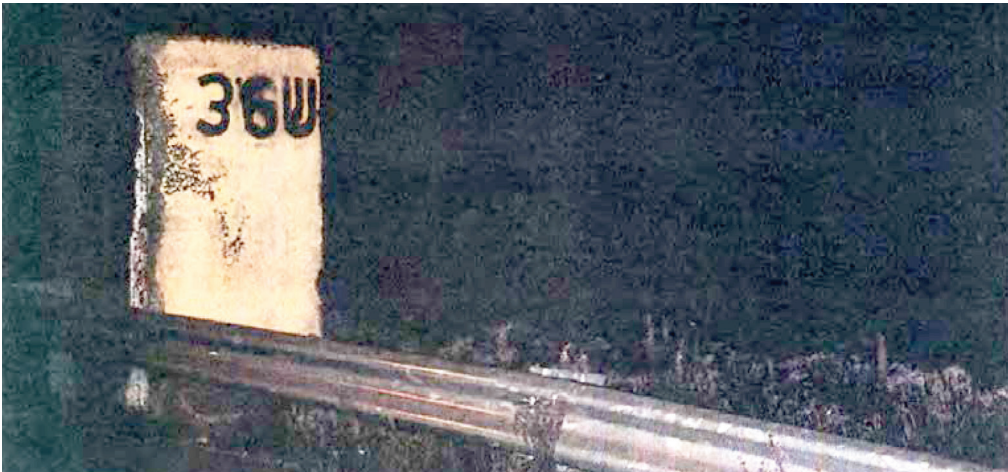
## Concrete barrier adjacent to a guardrail with no space for a clear zone\*

Source: Findings of an engineering inspection conducted during a police investigation of a fatal traffic accident on Route 57 at road marker 31.7 (the section between Einav and Shavei Shomron).

\* "Clear zone" – the space required between the guardrail wall prior to collision and the farthest point of the guardrail after collision.
